INTRODUCTION

Plymouth Engineering, Inc. was invited to do a feasibility investigation of the existing Greenville Maine Fire Department. The intent of the investigation is to create a cost analysis for the renovation of the building vs. creating a new building on site. Along with this analysis, the reconstruction of the building will be enough to trigger the existing building code be updated to adhere to current building codes of the ASCE 7-10 and IBC 2015.

The existing fire station is a 6,400 square-foot, steel-frame structure that was originally built in 1963. The interior consists of CMU and wood framing. The building condition is worn and dated but structurally sound even if it does not meet existing building code requirements. The building currently houses the Greenville Fire Department.

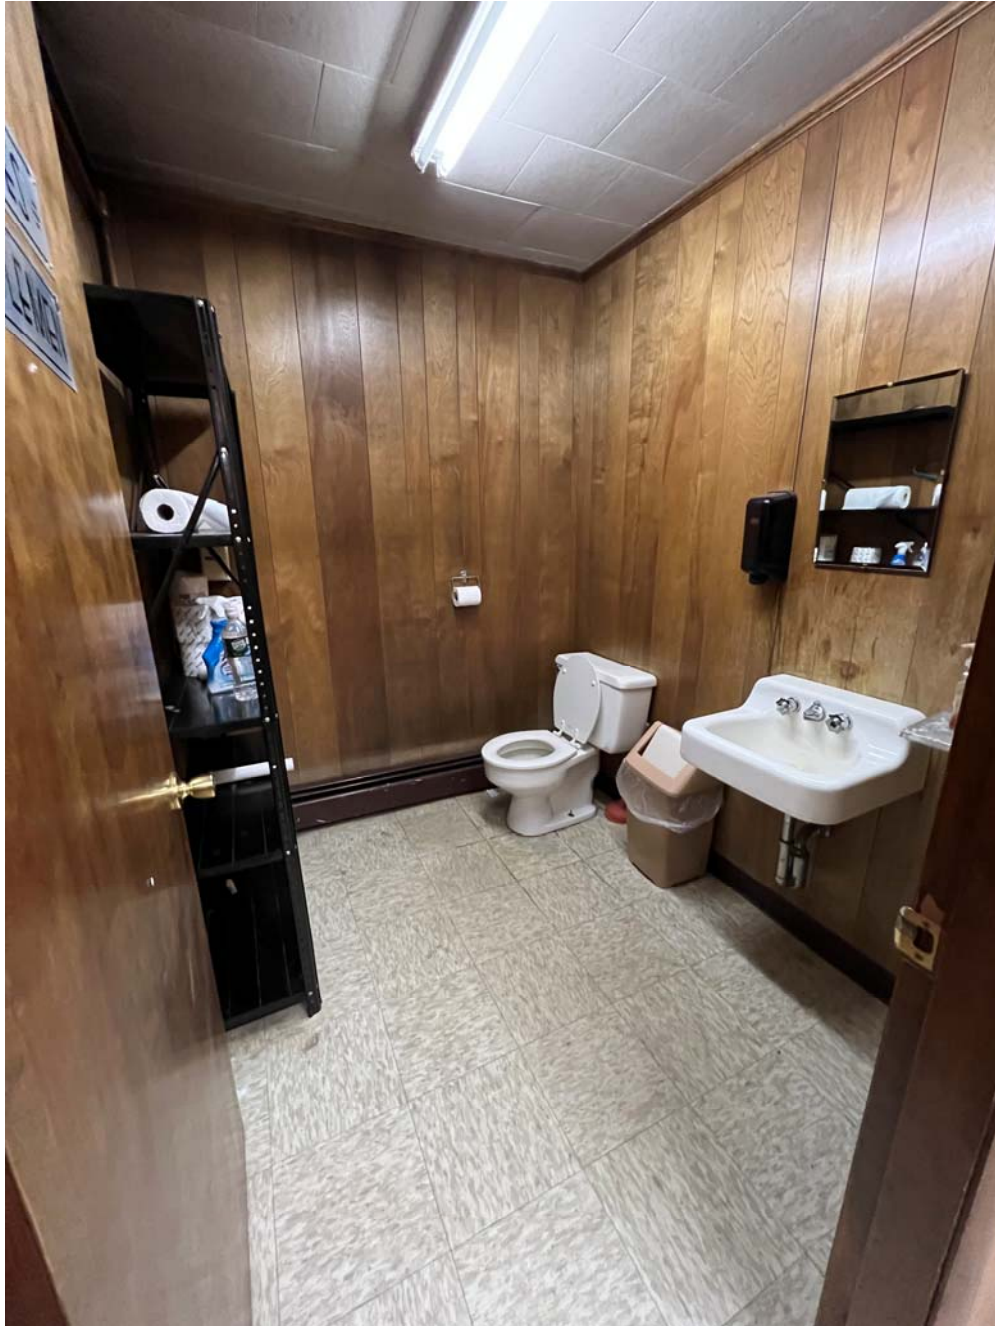
There is a single bathroom on site. It does not meet ADA requirements and will require upgrades to address the requirements of the Americans with Disabilities act. If any upgrades to the building are undertaken, the bathroom will also need to be updated to address the plumbing code.

Existing Bathroom needs upgrades

The bathroom will have to be upgraded and an additional bathroom will be needed to ensure it meets code.
